This **ERRATA Sheet** describes the latest known issues of easYgen-3000XT series devices. The following short identifiers are used:

Known issues:

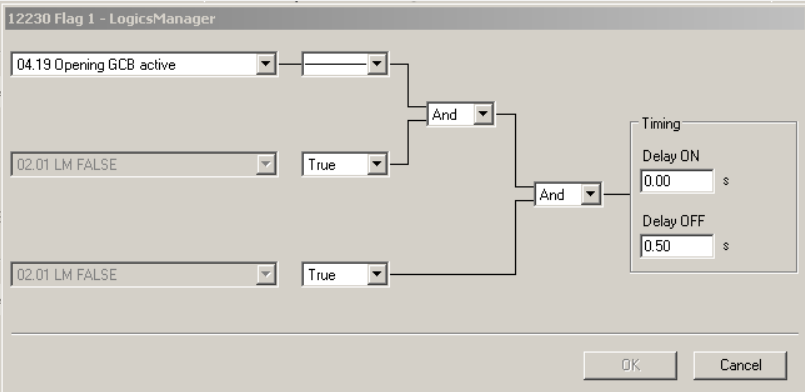
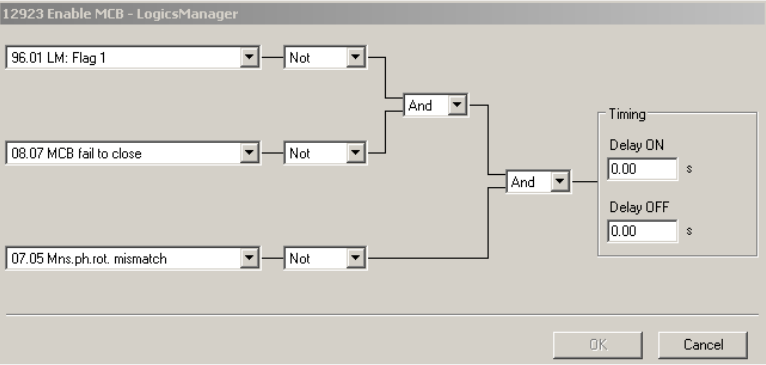
| # | Date / Affected | Description Remarks ToDo |
|---|---|---|
| XT-3K | | <p>If emergency run is active, "GCB auto unlock" can cause simultaneous deadbus closure of GCB and MCB if mains return during the "GCB open pulse". This can only happen in parallel logic if the "GCB open time pulse" (5708) is configured higher or same than 2 s. (This is because the mains settling time – which is shortened to 2 s in emergency case – and the "GCB open time pulse" are mismatched.)</p> <p><i>Will be updated asap by next revision.</i></p> <p>Possibilities to avoid this: If possible, configure "GCB open time pulse" (5708) shorter than 2 s. Configure a delay for enabling the MCB triggered by "04.19 Opening GCB". To do this, define an internal flag (e.g. Flag 1) and pass this flag to the LogicsManager "Enable MCB":</p> |

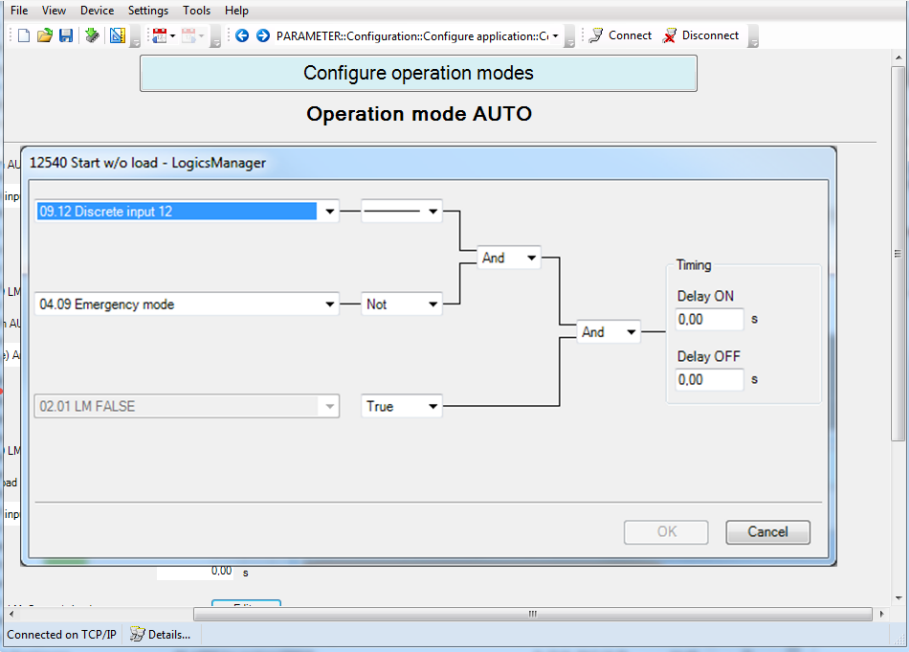
| # | Date / Affected | Description | |
|---|---|---|--|
| | 2017-01-31 | | The Auto mode "Start without load" ID12540 in conjunction with emergency run causes a frequently GCB close and open command, if "Enable MCB" ID12923 is removed (False) to the same time. (There is no internal prioritization for these two conflicting tasks.) |

| # | Date / Affected | Description | |
|---|---|---|--|
| | | | To avoid the auto mode "Start without load" ID12540 is active in exactly the same time the emergency run happens, do following: ((see next page)) |

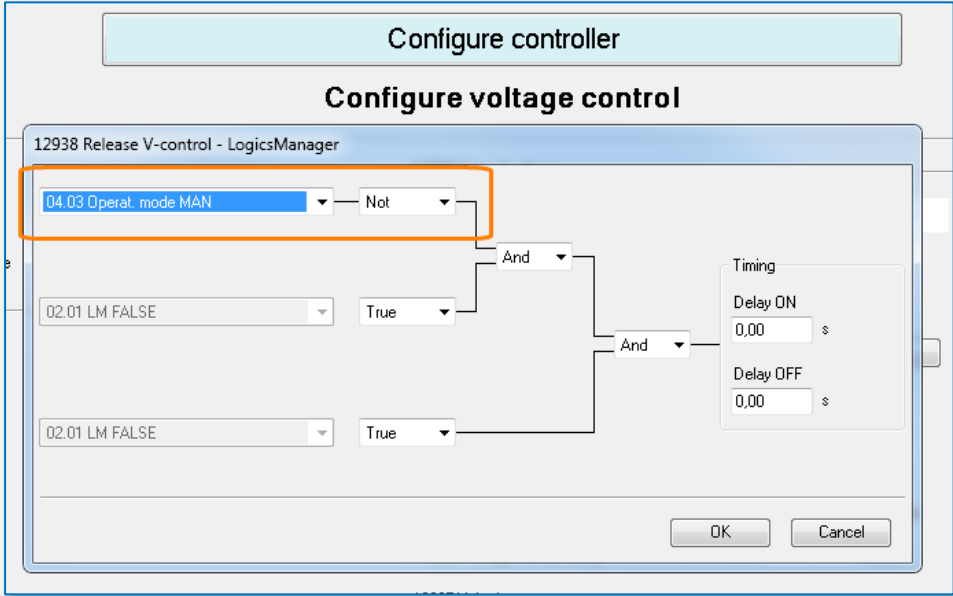
| # | Date / Affected | Description Remarks ToDo |
|---|---|--|
| | 2016-08-09 XT-3K | <p>In operation mode MANUAL if AVR is biased by the easYgen: The voltage regulation does not work correctly, if the device is configured with a PT ratio unequal to "1".</p> <p><i>The internal voltage setpoint value is calculated too high or too low. If the overvoltage or undervoltage monitor is enabled, a shut down will occur accordingly.</i></p> <ul style="list-style-type: none"> Don't use AVR in MANUAL mode if PT ratio is unequal to "1". <p>We are working to fix this bug fast. As a safety precaution, following setting is recommended: To use operation mode MANUAL (except manual synchronization), please set LogicsManager "Release V-control" ID 12938 to "NOT 04.03 Operat. Mode MAN":</p> |
