## **AO\_RM\_DVR Trip Setup for Redundant/TMR Systems**

**Power Generation, Compression, Other**

Please reference publication **51552**.

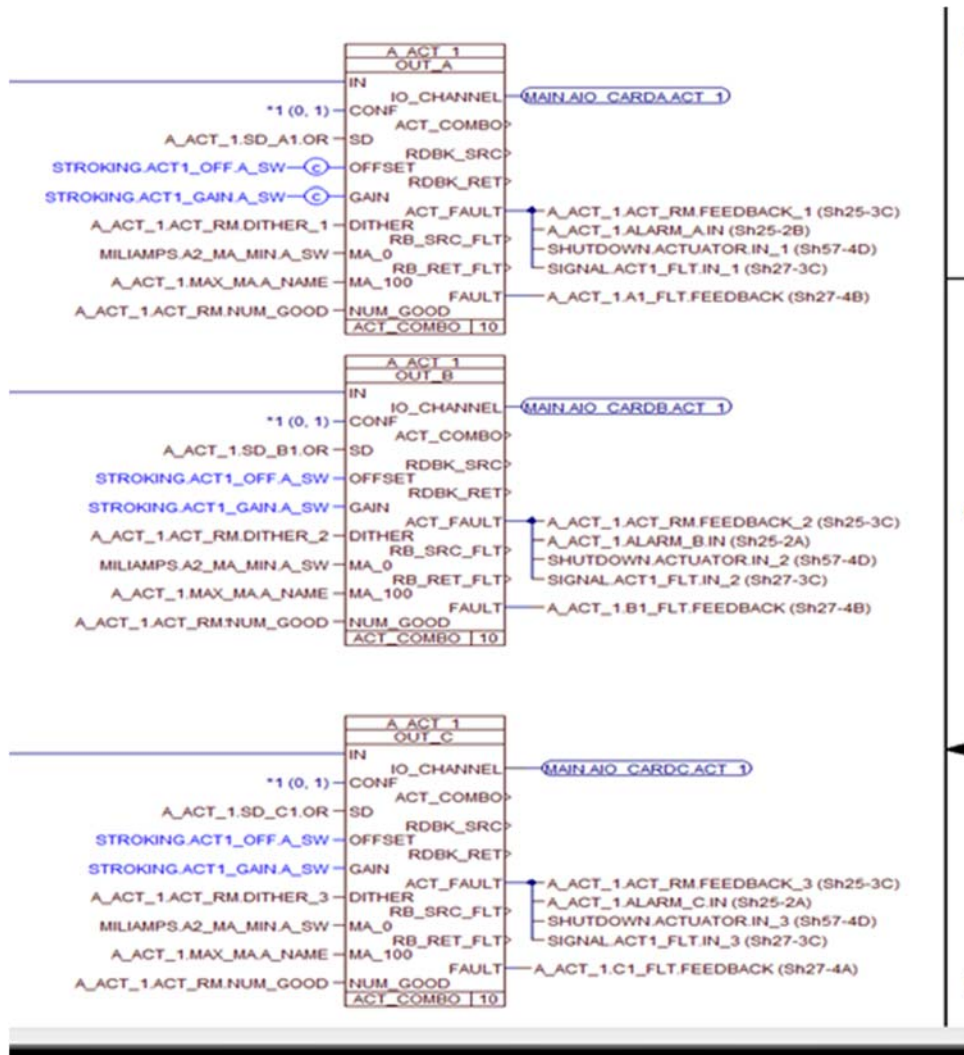
Example 1

Woodward India requested assistance when one of their customers had a turbine shutdown while resetting the "B" kernel CPU in a TMR application, using coder 2.10. There was a hardware failure in the CPU, which prompted the customer to replace the CPU. Once the CPU was reset, the turbine tripped on Loss of Actuator. The trip occurred when the "ACT\_FAULT" output on the "ACT\_COMBO" block went true for all of the outputs. See Examples 1 and 2.

The ACT\_FAULT goes true whenever the Source and the Readback current has an error of greater than 10%. In a TMR system, if all 3 kernels are working correctly, the source current will be divided equally among 3 cards and the readback current is divided equally between 3 cards. If a CPU has failed (in I/O Lock), the source current is divided equally between 2 cards; however the readback current is still divided equally between 3 cards, as the card readback electronics are still active. Because of this difference the ACT\_FAULT will go True on the Kernel with an active CPU. Once the failed CPU has been replaced, and reset, the ACT\_FAULT will be true for all 3 Kernels for a few seconds, as the board diagnostics are executed. Because there will be a few seconds where all of the ACT\_FAULTS will be true, this caused a Shutdown in the System. When testing the same application in Coder 5.04, the turbine would trip immediately on a CPU failure as detailed above.
